**Capsule Summary**  
**BA-0129**  
**Gorsuch Stone Barn**  
**15900 York Road**  
**Sparks, Baltimore County**  
**ca. 1841**  
**Private**

## Maryland Inventory of Historic Properties Form

Inventory No. BA-0129

historic      Gorsuch Stone Barn

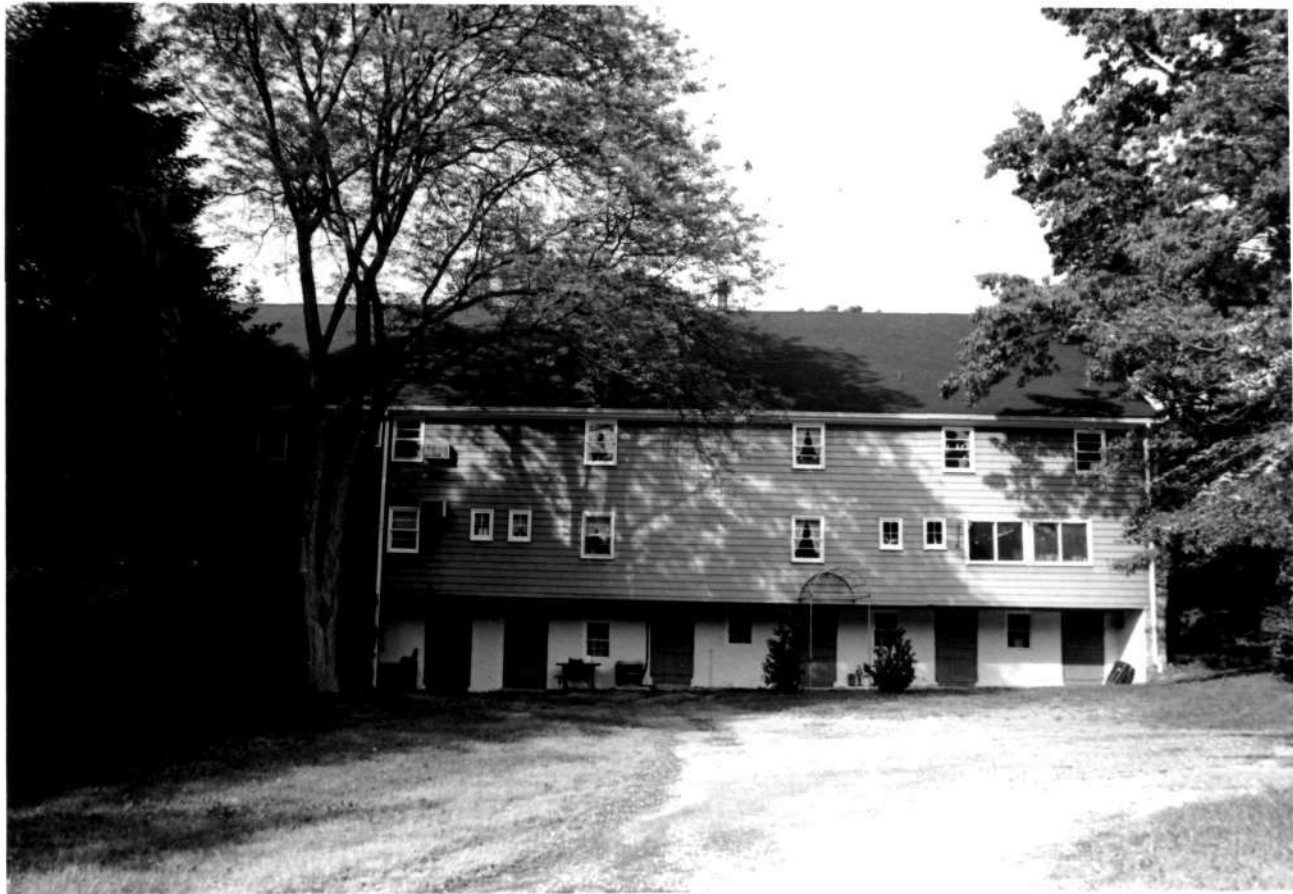
30F8

MD SHPO  
SOUTHERN ELEVATION, LOOKING NORTH EAST

The rear, or southwest, elevation of the barn retains its general appearance as a German bank barn, but has been re-clad in aluminum siding and windows have been added. The stuccoed ground floor, located under the cantilevered overhang, originally housed animals. Seven 6/6 wood windows with molded wood surrounds and sills are interspersed with eight single-leaf Dutch vertical board wood doors detailed with strap hinges. Two bays are further sheltered by a wall that is flush with the above story exterior wall. The second floor is pierced with three horizontally oriented 2/2 wood windows, two sets of paired casement one-lights and four casement four-light windows. They each have molded wood surrounds and sills. The wrap-around wood deck on the western corner of the building is accessed from a second story double-leaf sliding glass door. The third story has nine 2/2 horizontally oriented metal windows.

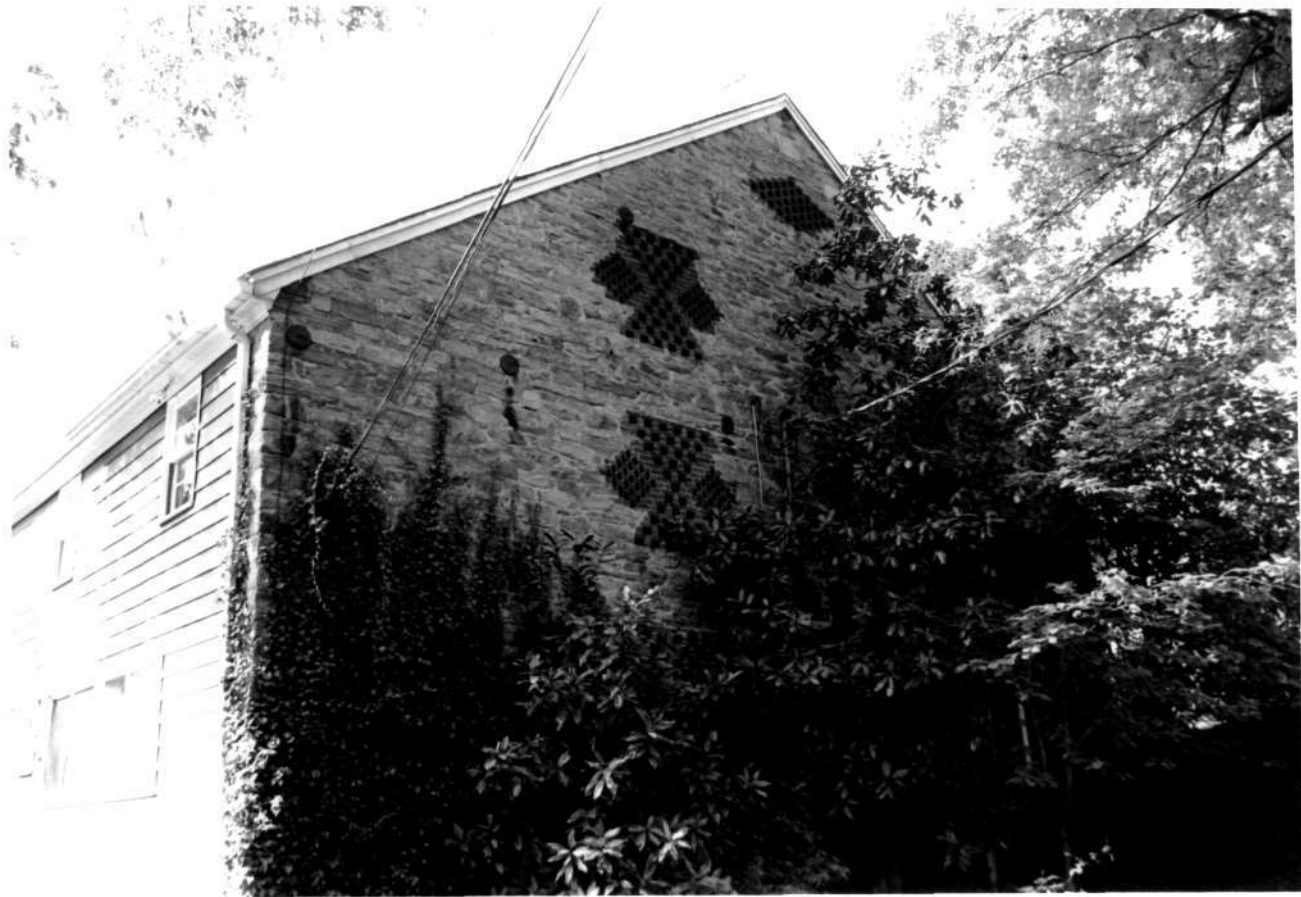
BA 129  
15900 YORK ROAD  
BALTIMORE COUNTY  
TRACERIES  
5/00  
MD SHPO  
SOUTHEAST CORNER, LOOKING NORTH  
4 OF 8

The southeast end of the barn retains its original ventilation brick patterning with two diamond- and hourglass-shaped ventilation designs on the first, second, and attic stories. They are constructed of brick headers and stretchers. The designs are tied into the stone structure to provide light and ventilation for the barn. Another diamond-patterned ventilator is located in the gabled peak. However, alterations to the original structure have occurred. These include the addition of two 6/6 wood windows with molded wood surrounds on the ground floor, where a single-leaf three-light and paneled wood door is also located.

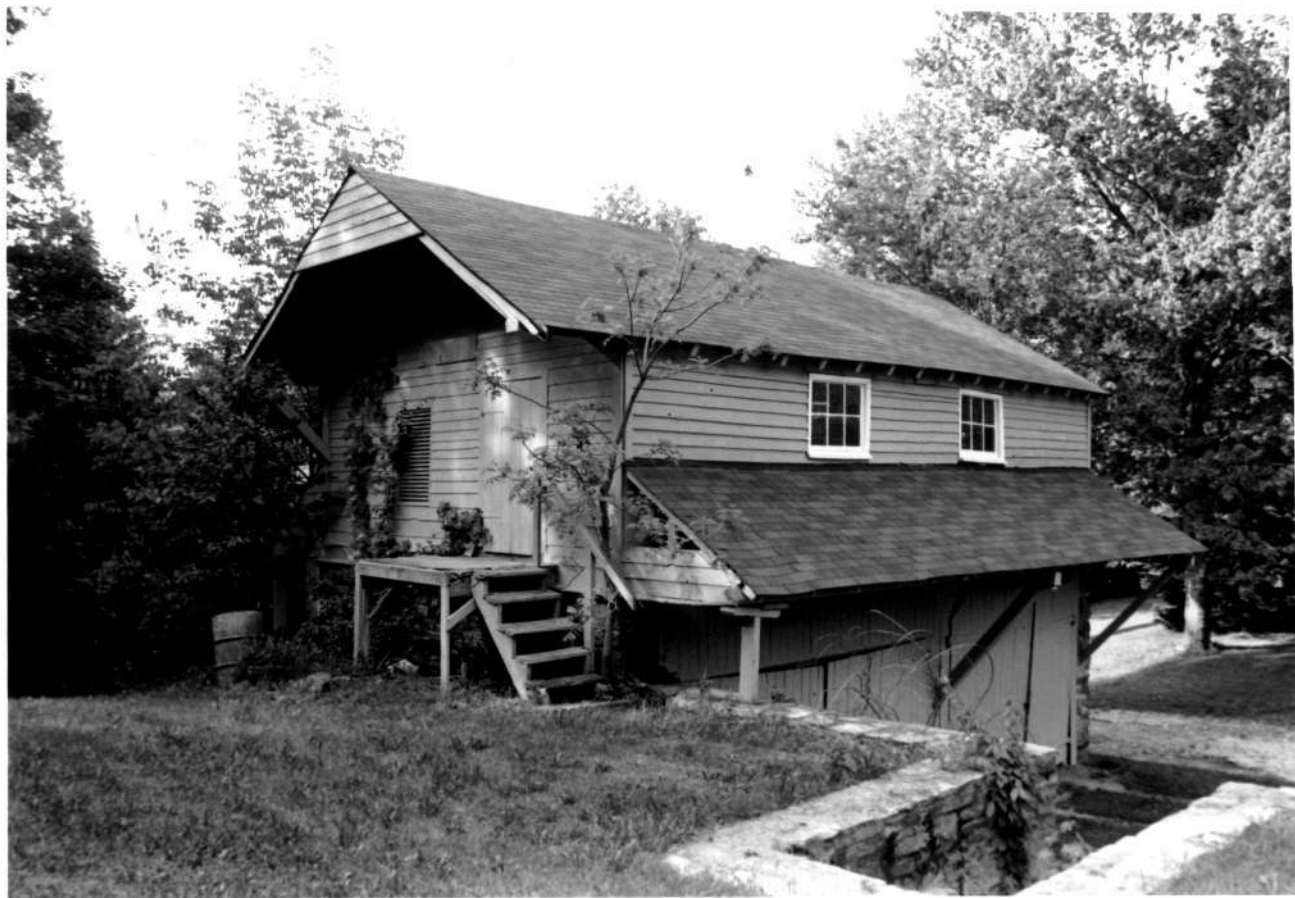
5 OF 8

BA129  
15900 YORK ROAD  
BALTIMORE COUNTY  
TRACERIES  
5/00  
MDSHPO  
CORNCRIB, SOUTHEAST CORNER,  
LOOKING NORTH

A corn crib was built circa 1910 on the foundation of a previous stone barn built by John Gorsuch in 1841 that was destroyed by fire. The two-story building was built into the bank, on much of the old stone foundation. The corn crib is clad in weatherboard and displays overhanging eaves with exposed rafter tails. The main entry is sheltered by an extension of the eaves and displays a triangular weatherboard pattern in the gable end. A side shed roof shelters the lower portion.

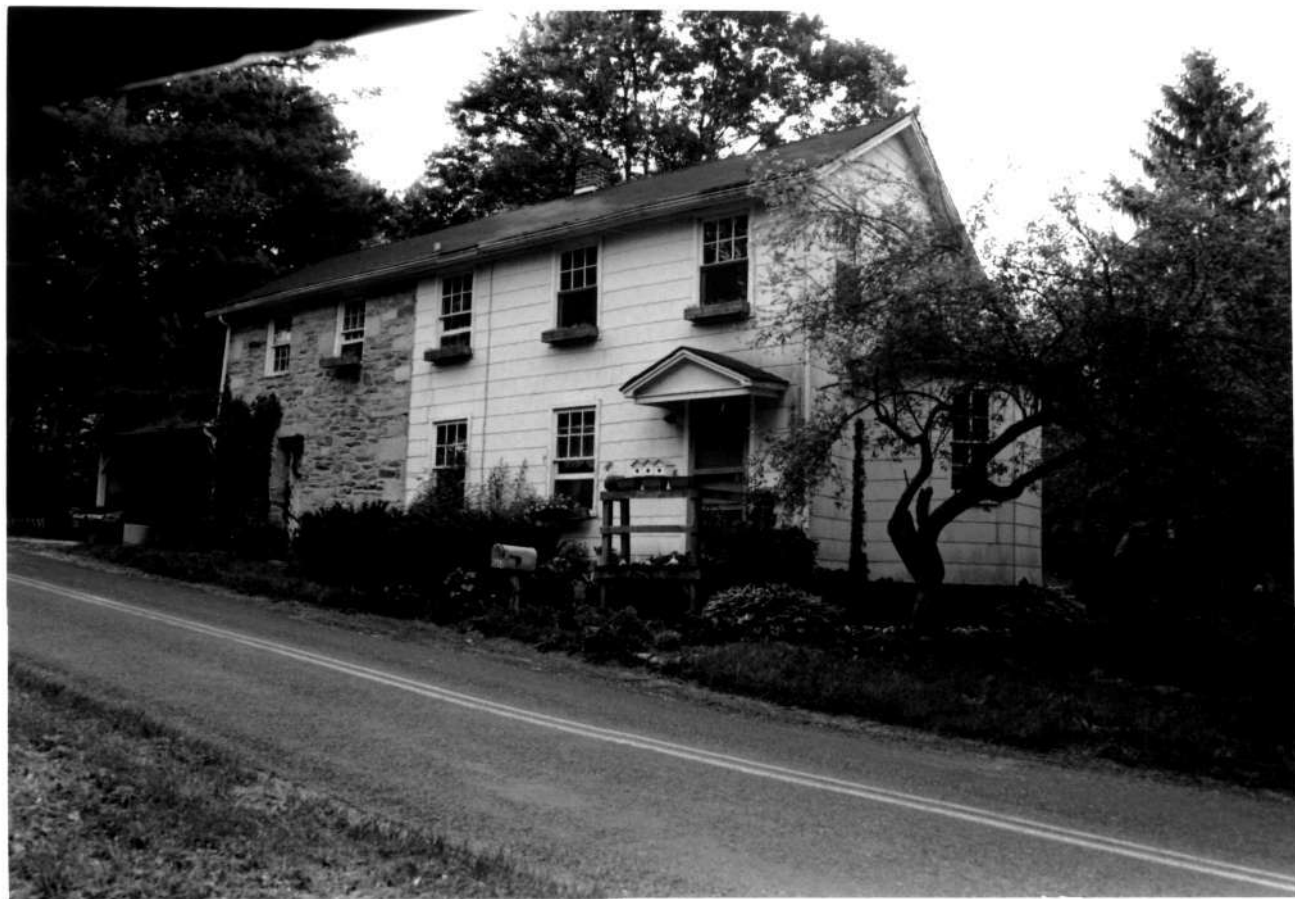
6 OF 8

BA 129  
15900 YORK ROAD  
BALTIMORE COUNTY  
TRACERIES  
5/00  
MD SHPO  
TENANT HOUSE  
NORTHEAST CORNER LOOKING SOUTH

The side gable roofed tenant house was constructed circa 1850 and was remodeled after it partially burned in the late 19<sup>th</sup> century. The east side of the house faces Ensor Mill Road and consists of five bays. The original stone portion of the original structure consists of the two-story section on the southern end. The first story of this portion has single-leaf wood paneled door with a recessed surround and stone lintel. The second story has two 6/6 windows. This portion of the dwelling has stone quoins and a stone foundation. No chimney was visible in

the original portion, and it is speculated that the chimney may have been destroyed by fire in 1916. There is a one-story gabled garage addition supported by bracketed wood posts. A two-story three-bay addition, under the same roof as the original portion, was added in 1917 after the fire. It displays the original stone foundation and asbestos shingle cladding. There is an off-center single-leaf paneled wood door with a pedimented overhang. The dwelling displays a five-sided bay window and a rear one-story shed addition.

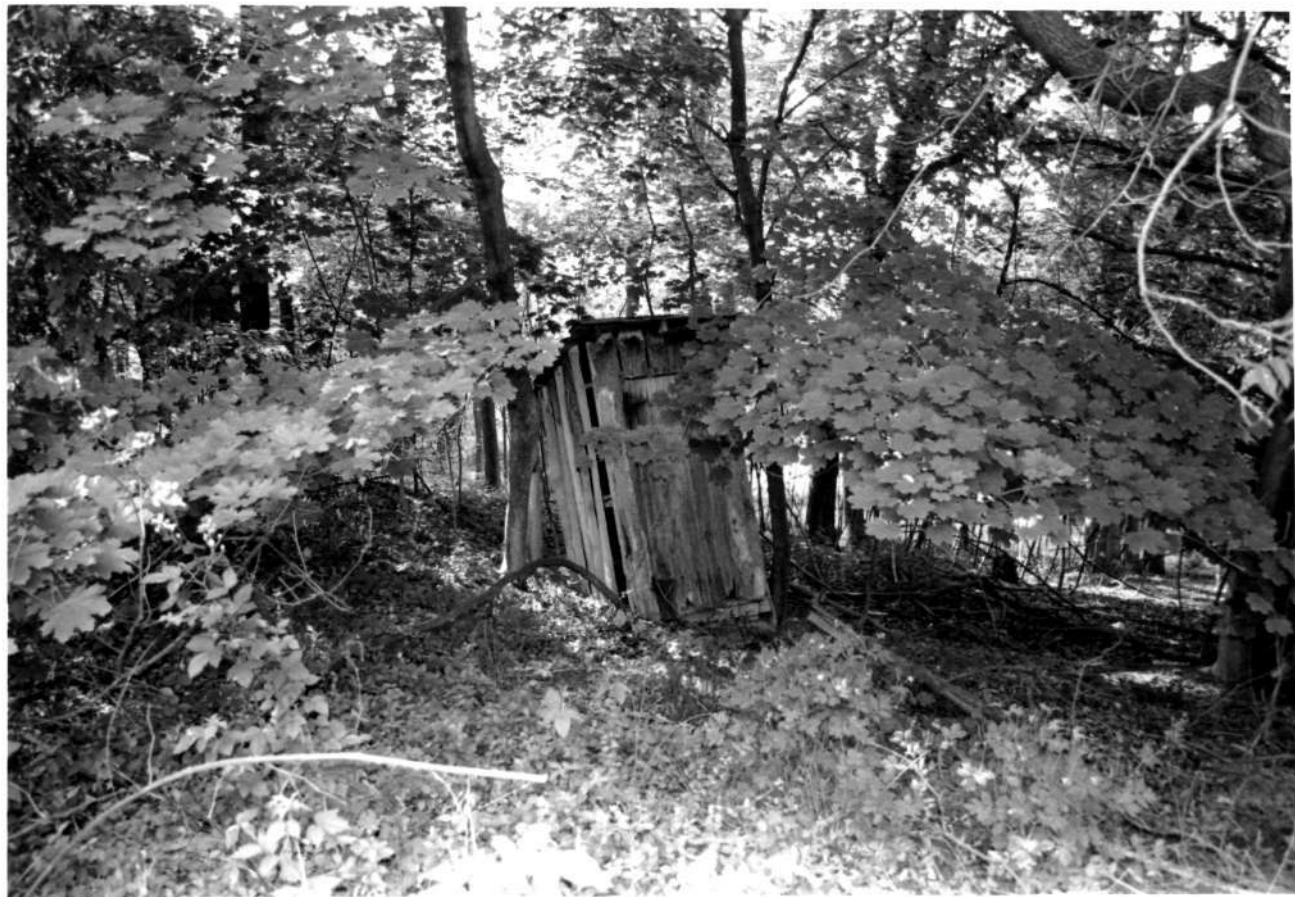
7 of 8

BA 129  
15900 YORK ROAD  
BALTIMORE COUNTY  
TRACERIES  
5/00  
MDSHPO  
OUTHUSE, EASTERN ELEVATION  
LOOKING NORTHWEST

A small, one-bay early twentieth century wood outhouse is also present on the premises. It is constructed of vertical board with a shed roof. The structure displays overhanging eaves, a single-leaf entry and exposed rafter tails.

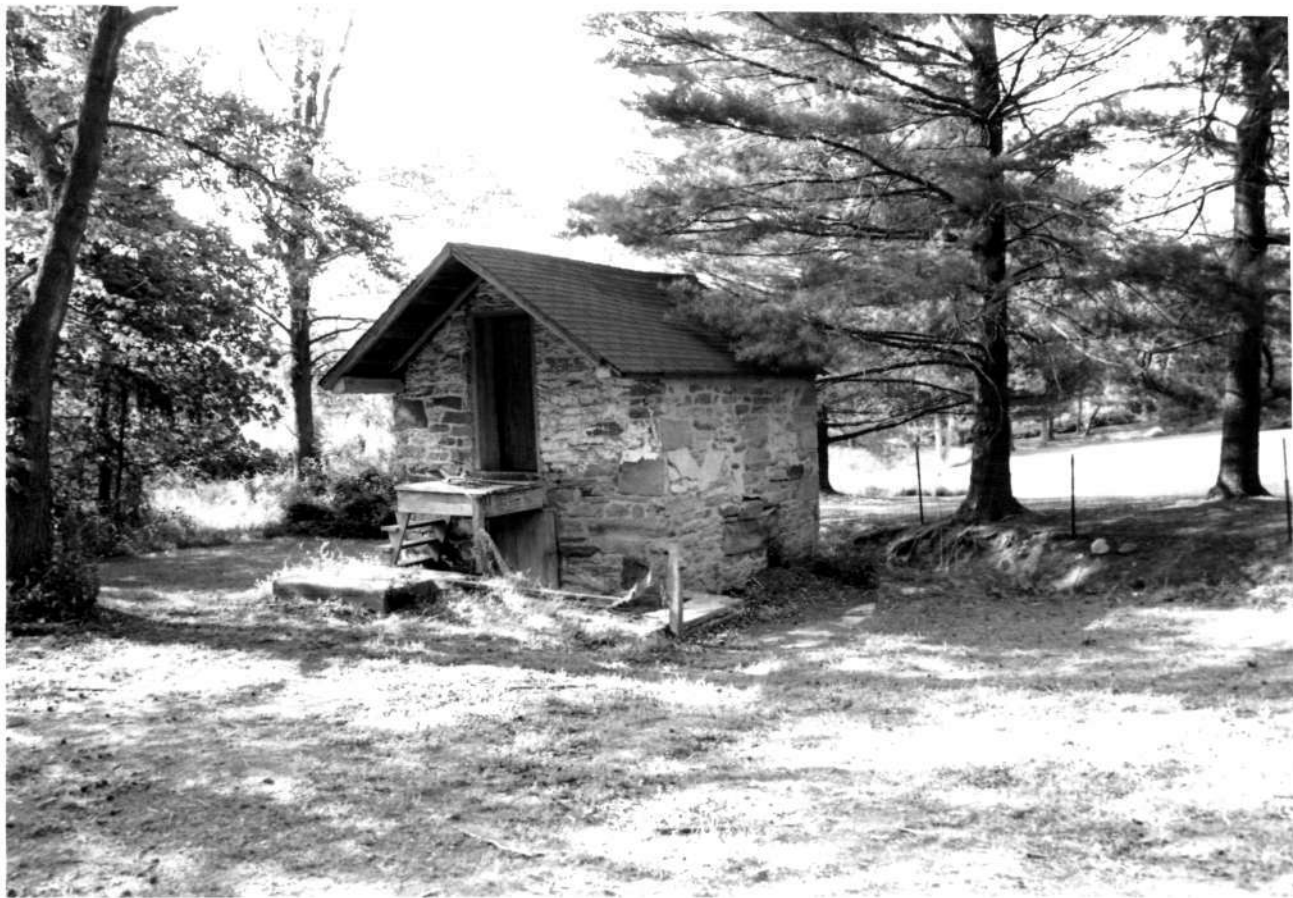
8 OF 8

BA 129  
15900 YORK ROAD  
BALTIMORE COUNTY  
TRACERIES  
5/00  
MDSHPO  
ICEHOUSE, NORTHEAST CORNER
